POULTRY PROCESSOR,

Ice Pigging Case Study

The Project – Waste Water

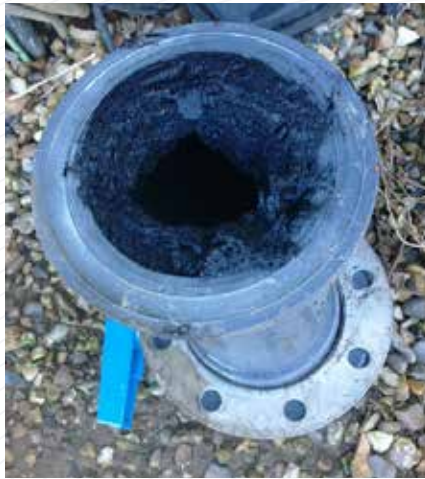
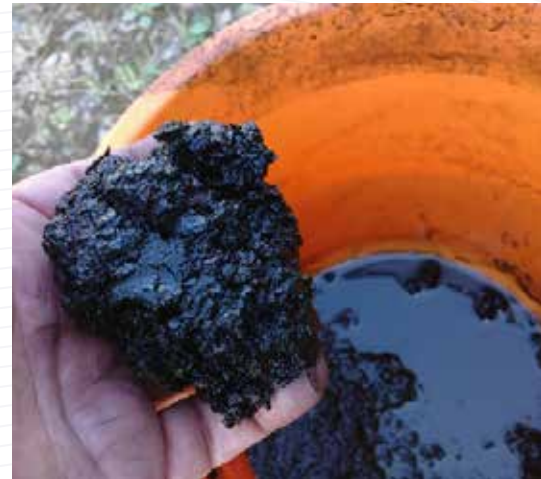
Sludge deposits that were cleaned from inside the pipe walls.

Ice Pigging was used to clean and clear a waste effluent main that was experiencing decreased flow rates due to a build-up of abattoir waste on its pipe wall. Approximately 2000m of MDPE piping was cleaned in just two visits, showing significant flow improvement of 100%.
